Experience with Reinforced Plastic Primary Aircraft Structures

F. S. Snyder and R. E. Drake
Piper Aircraft Corp.

Automotive Engineering Congress
Detroit, Mich.
Jan. 14-18, 1963

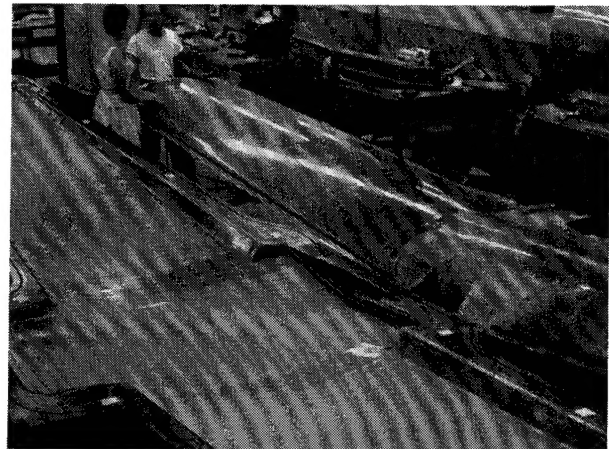
Fig. 4 - Wing skins and mold

Molds - In all stages of the project, plastic molds had to be developed and built before parts could be molded or tested. Glue lines of the various parts to a great extent controlled the size and shape of the part as well as the mold. The molds would be somewhat larger than the plan view of the parts. (The wing mold would measure about 27 ft long; Fig. 4.)

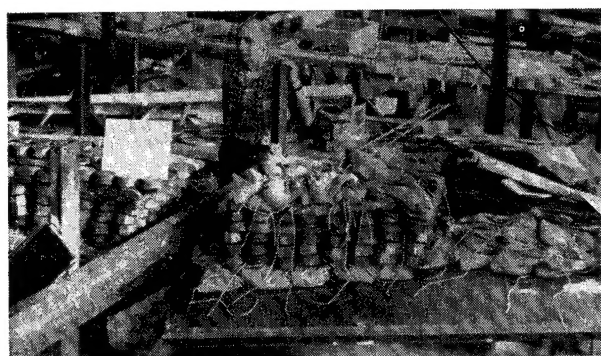
Fig. 8 - Static test setup for inverted loads

by insufficient spreading of the load. The fitting test is shown in Fig. 8. This was carried to 200% with no signs of distress.
